Inspection Report

Property Address:
2962 Griffin Ave.
Toledo, OH 24014

RW Huntley Home Inspection, LLC

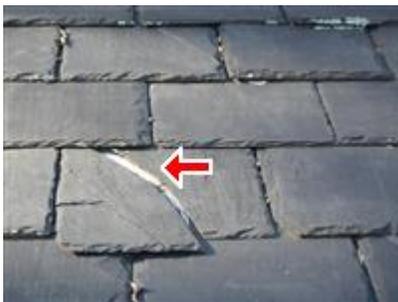
1. (#SHINGLES) There is at least one broken slate shingle on the roof. Although there are several layers of materials on the roof to prevent weather damage, damaged or missing shingles should be considered for repair immediately.
 - (SURFACE) There are areas of roofing where nail heads are exposed at the surface. One should consider these nails as a breach in the roofing and vulnerable to leakage. It is advisable to cover them with some water-resistant product (FYI).
 - (POPS) There are one or more nail pops evident at the roofing shingles. This is a common occurrence with asphalt shingles. Considering that the shingles are covering the nail or other issue, we cannot directly observe the problem. It is advisable to re-establish a flat roof surface to prevent water penetration (FYI).

1.0 Picture 1 Broken slate

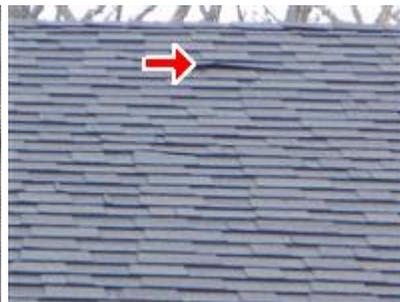
1.0 Picture 3 Nail pop

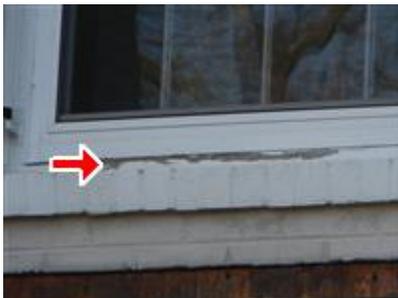
- (PEEL) Portions of the protective coating for the wood trim and/or siding on the exterior of the house is peeling/deteriorating. It is advisable to maintain a protective coating on exterior wood to prevent decay (FYI).
- (LEAD) Because this house was built prior to 1978, it is possible there is some lead present in the paint, plaster, window glazing or other product. Lead has been identified with having certain health risks. We have not identified the presence of any lead as part of this inspection. It is advisable for homes pre-dating 1978 to identify products containing lead before remodeling or otherwise creating dust out of these materials. (FYI).
- (GAP) There is a hole in the exterior siding/trim. To prevent penetration by pests or loss of conditioned air from the home it would be advisable to seal any gaps (FYI).

2.0 Picture 1 Ex. exterior maintenance

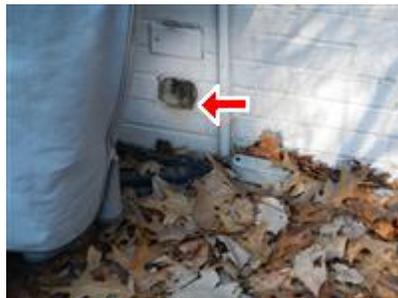
2.0 Picture 2 Gap at exterior

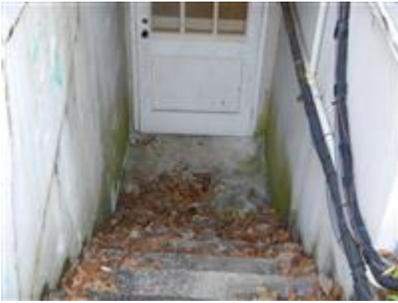
- (RAILS) There are no handrails at the front and rear yard steps. If there is a drop of 18" or more along any point of these steps or, if there are three or more steps together, it is advisable to have a secure and graspable handrail (FYI).

2.3 Picture 1 Ex. no rail

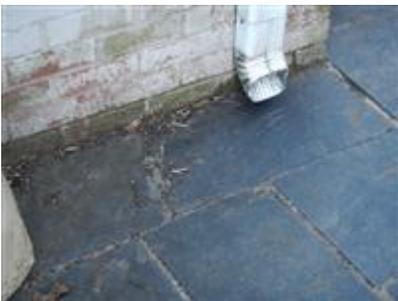
- (EXTEND) It is advisable to extend all gutter downspouts as far away from the foundation of the house as practical. Groundwater near the foundation is one of the primary causes of instability and premature settlement of a house (FYI).

2.4 Picture 1 Extend all downspouts

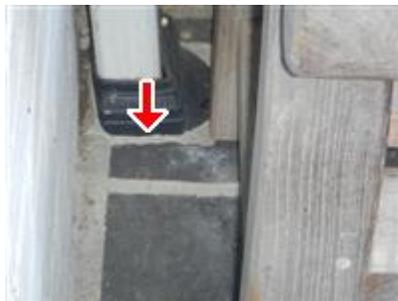
2.4 Picture 2 Ex. buried drains

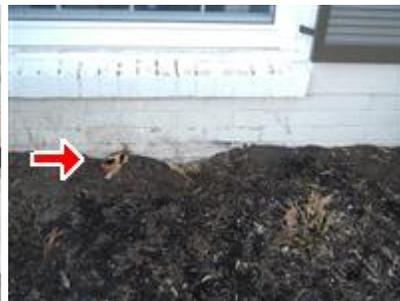
- (HIGH) The soil/mulch at the base of the home exterior is in contact with brick veneer. Standard practice is that soil/mulch at grade not rise above the coated foundation wall. To prevent wicking of soil moisture into the brick veneer (and subsequently into the underlying wood framing) it is advisable to lower the grade or, establish a barrier between the moisture and the brick such as a channel filled with gravel (FYI).

2.4 Picture 3 Ex. high soil mulch/no weeps

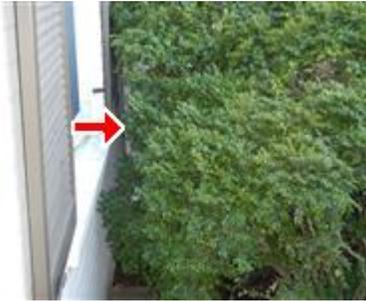
- (SHRUBS) Close growth of shrubs/trees at the wall of the house can permit insects/pests a convenient bridge to enter cracks into the house. It is advisable to keep shrubs cut back roughly 8-12 inches from exterior walls. Also due to the presence of thick, tall, or close shrubs, we are unable to see the full exterior of the house clearly. There is a possibility there is some defect(s) we are not able to see (FYI).

2.4 Picture 4 Ex. close shrubs

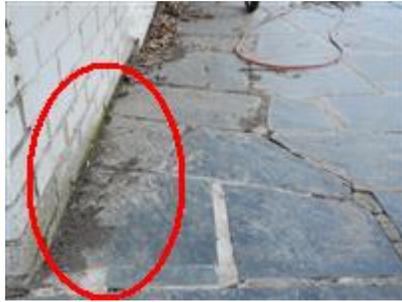
- (CATCH) There is at least one low point in the landscape next the foundation of the house (as discussed-see photos). Such a low spot will tend to "catch" water and direct it toward the foundation. It is advisable to establish an even grade sloped away from the foundation to prevent undue moisture exposure (FYI).

2.4 Picture 5 Ex. low spot

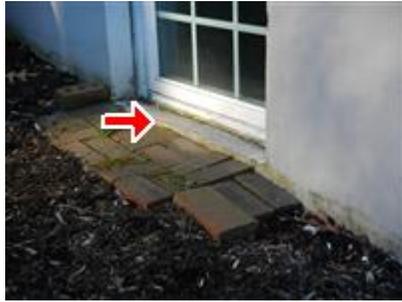
- (WELLS) One of the windows is at ground level without a window well. Without drainage of some sort at these low windows there is a high risk of water intrusion through the window/window area. It is advisable to establish some form of drainage at low windows such as a well (FYI).

2.4 Picture 6 Window on grade

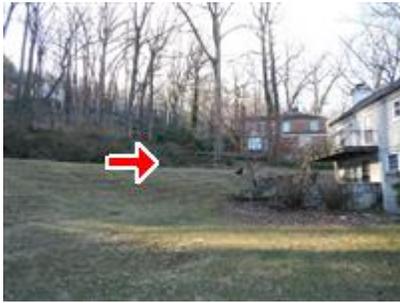
- (GRADE) There is a negative slope at the right side (facing front) and rear of home which may cause or contribute to water intrusion or deterioration. It is advisable to monitor the pattern of water flow toward, and around, the house during heavy rains. If it is necessary one should consider taking measures to prevent intrusion of water into the house (FYI).

2.4 Picture 7 Ex. drain slope

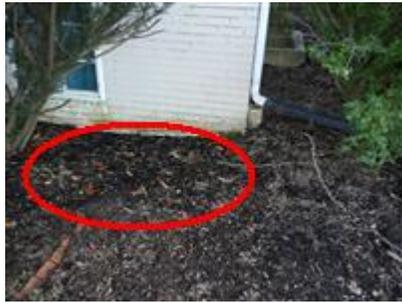
2.4 Picture 8 Low area/poor drainage

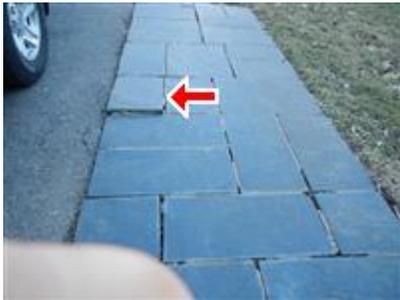
- (UNEVEN) The walkway at the front of home has gaps/holes/cracks such that it is a possible trip hazard. It is advisable to level this area (FYI).

2.7 Picture 1 Trip hazard

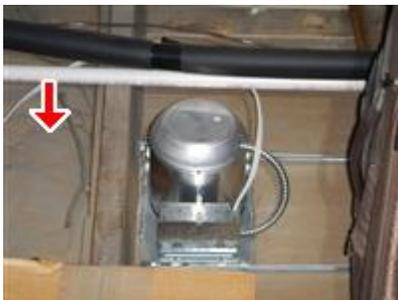
- (GAPS) There are one or more gaps in insulation coverage at the attic floor. Such gaps will permit loss of home heating in the winter and conduction of attic heat during the summer. If your photos shows a gap of both ceiling material as well as insulation this is a deficiency in fire-stop function between the house and the attic. It is advisable to establish a complete covering of insulation between all conditioned and unconditioned spaces of the house (FYI).
- (COVERED) Much of the wall and ceiling space in the downstairs is covered with, drywall, paneling, etc. and some components are not readily visible for inspection. We find no problem in this area unless mentioned specifically elsewhere in this report (RES).

3.0 Picture 1 Ex. insulation gaps

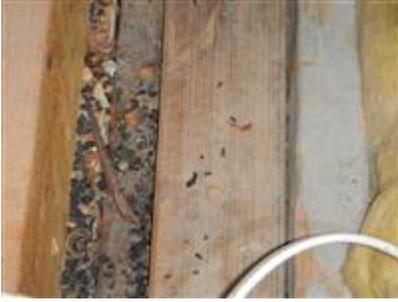
- (PESTS) There are what appear to be mouse droppings in the attic crawl space. We have not determined any potential health consequences of any pests in the house. For a definitive comment of the type and degree of habitation within the structure, one would need to consult a specialist (FYI).

3.3 Picture 1 Evidence of pests

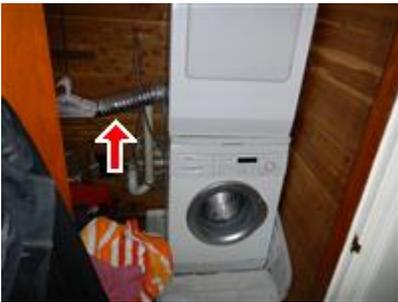
- (FLEX) The dryer vent is currently utilizing a flexible hose which is subject to collecting lint and overheating when not cleaned periodically. It is considered current safety standard to replace flexible vents with rigid metal vents (FYI).

3.4 Picture 1 Flex vent

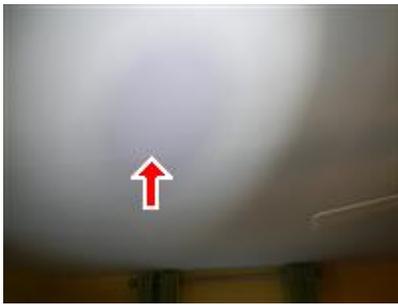
- (CRACKS) There are one or more cracks on the interior walls and ceiling that fall within the description of "typical" or otherwise insignificant. It is always advisable to monitor these or any cracks to see if they worsen. We find no structural significance to these cracks unless mentioned elsewhere in this report (FYI).
- (STAINS-DRY) The attic ceiling has one or more stains apparently from water intrusion. A representative number of these stains were tested with a moisture meter and found to be dry at this time. If it has not rained or snowed in days/weeks, it is advisable to check for dampness when water has been on the roof. The newer the roof, the less the likelihood these are actually active but, from any number of years ago from a prior failing roof or flashing (FYI)

4.1 Picture 1 Ex. typical cracks

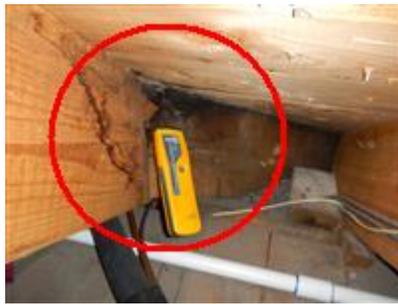
4.1 Picture 2 Ex. water stains-dry

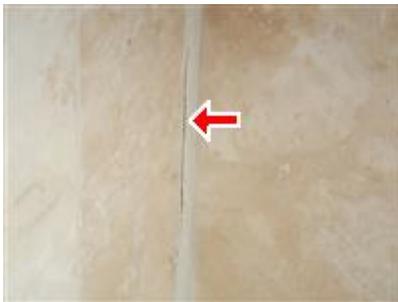
- (TILE) The tile surround and floor at the bathtub wall and shower floor is deteriorated to some degree. Leakage seepage of water from the shower area can contribute to damage to the adjacent walls/floors. The adjacent damage may or not be visible. It is advisable to establish a sealed shower enclosure to prevent escape of water into these adjacent areas (FYI).

4.2 Picture 1 Gap at shower

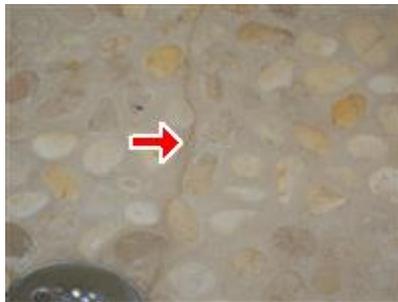
4.2 Picture 2 Developing gap at floor

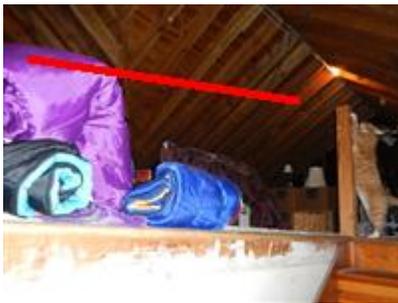
- (RAILS) There is no guardrail at the attic stair landing. If there is a drop of 18" or more along any point of these steps or, if there are three or more steps together, it is advisable to have a strong guardrail (FYI).
- (GAP) The gaps in the spiral baluster rails greatly exceeds the standard of 4 inches. This standard may or may not have been in place when this deck was constructed. It is, however, a safety concern if small children may be able to fit between the rails (see <http://www.rwhuntley.com/research>).
- (RAIL) The hand/guard rail for the spiral case is loose. It is advisable that the loose connection be fixed and restored to a load bearing standard of 200 lbs.

4.4 Picture 1 Guardrail upgrade

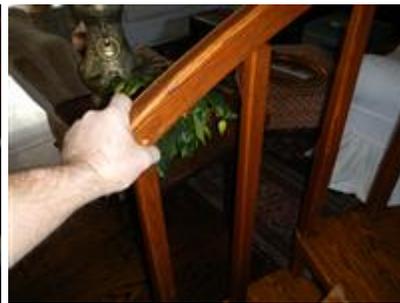
4.4 Picture 3 Loose bottom post and rail

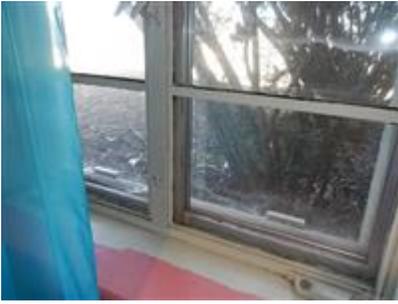
- (STUCK) There is a window in the downstairs bedroom which is stuck shut and missing crank handles. We find no correlation with these window and structural problems but this is an important means of escape in case of fire and should be made operable. For a definitive comment on this issue one would need to consult a specialist (FYI).

4.6 Picture 1 Stuck window

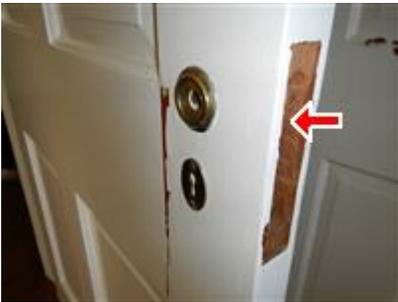
- (HARDWARE) One or more doors has loose or missing hardware. It is not the intention of a standard home inspection to account for minor maintenance of such hardware (FYI).
- (ADJUST) One or more doors in the house requires some adjustment to operate smoothly. It is not the intention of this report to necessarily document small adjustments and maintenance issues (FYI).

4.7 Picture 1 Missing hardware

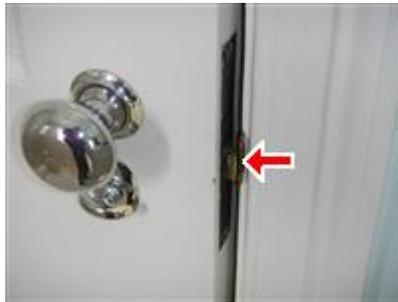
4.7 Picture 2 Ex. door adjustment

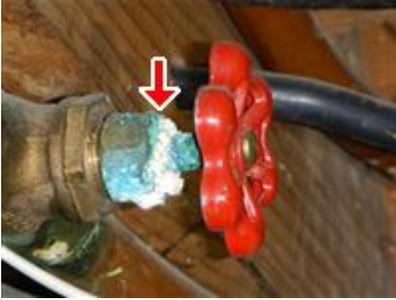
1. (LEAK) There is a leak in the plumbing at the basement valve. It is advisable to correct any leaky component to prevent damage to surrounding components and/or the component itself. For a definitive comment on this issue one would need to consult with a licensed plumber. Repair or replace as necessary.

5.1 Picture 1 Leak at valve

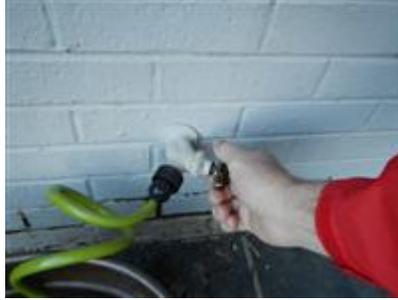
5.1 Picture 2 No water

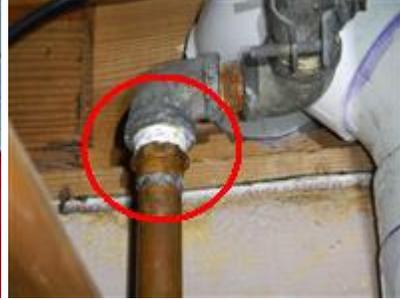
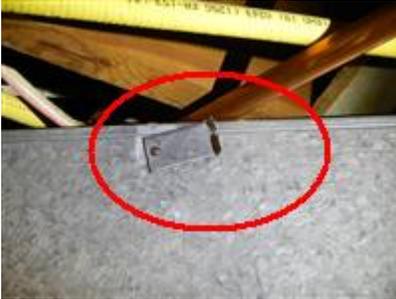
- (GALVANIC) Some pipes in the basement are incompatible metals in contact with one another (e.g. copper on steel). Such an incompatibility will tend to lead to point erosion and eventual leakage. Such leakage will

tend to take decades to occur, however. It is standard practice to use brass to connect copper and steel pipes. It is advisable to use like-metal pipe hangers and otherwise keep incompatible metals from touching. Repair or replace as necessary (FYI)

5.1 Picture 3 Ex. incompatible metals

5.1 Picture 4 Ex. incompatible metals

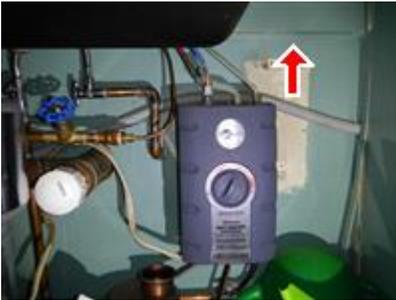
- (HIGH) The dishwasher drain line has not been installed with a "high loop." Most jurisdictions and manufacturers require this loop to prevent water from being pulled back into the washer or even from being siphoned back into the water supply. It is advisable to implement a high loop before using the appliance.
- (LOOSE) The toilet is loose at floor at the guest bathroom. Although not necessarily significant on its own, a loose toilet will contribute to deterioration of the wax seal at the base of the toilet. It is advisable to secure all toilets firmly to the floor (FYI).

5.2 Picture 1 Missing high loop

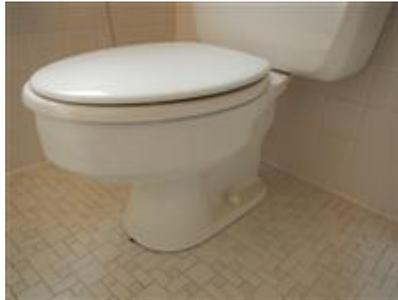
5.2 Picture 2 Loose toilet

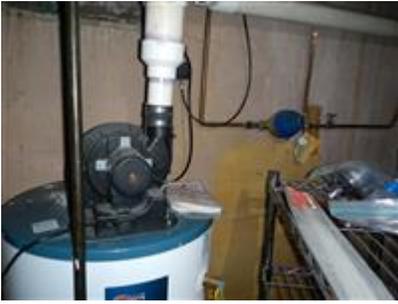
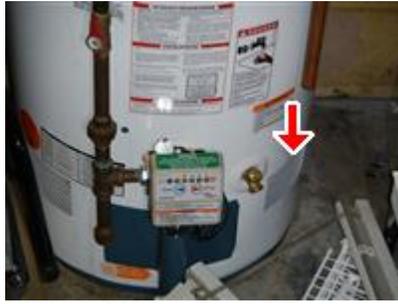
1. (EXP. TANK) The water heater is on a closed water system without benefit of an expansion tank. Recent changes in standard of practice require one when a new water heater is installed. We observed no leaks or drips at the T&P valve during inspection. It is advisable to install an expansion tank to reduce the chance of pressure problems at the pressure relief valve, the tank or other fixtures. For a densities comment on this issue it is advisable to consult with a licensed plumbing contractor.
2. (T/P VALVE) The temperature/pressure relief valve on the water heater is not equipped with a proper extension pipe. The recognized standard is a 3/4", high-temperature rated pipe to extend within 6 inches of the floor. It is advisable to install a proper extension to minimize the risk of injury if the valve should open.

5.3 Picture 1 Expansion tank upgrade

5.3 Picture 2 Short extension pipe

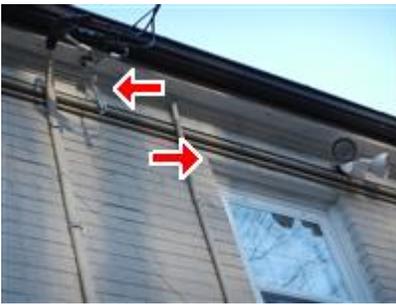
1. (EXPOSE) The main electrical service is close to a traffic area and may constitute and exposure hazard. If the cable is within 3 feet of a door or window it is advisable to remove this hazard be eliminating the opening or moving the cable.

6.1 Picture 1 Service close to window

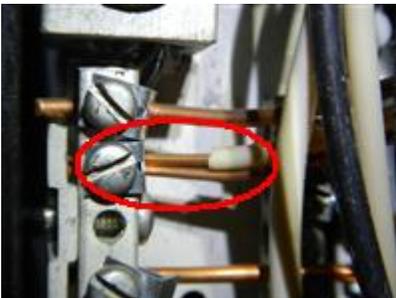
6.2 Picture 1 Ex. doubled neutral connection

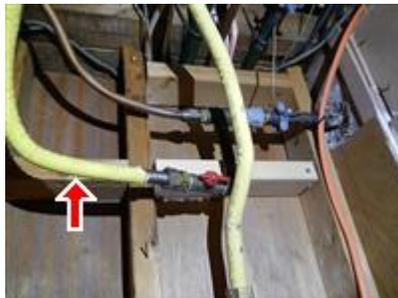
2. (GAS BOND) There is corrugated stainless steel gas tube (CSST) being used in the house and we do not see where it is bonded to the electrical panel. Bonding this thin material is necessary to prevent unintended electrical current (lightning, power surge, etc.) from damaging the gas line. It is advisable to clamp a bond and run it to the electrical panel. For a definitive comment on this issue, one would need to consult a licensed electrician or HVAC specialist.

6.2 Picture 2 Ex. CSST not bonded

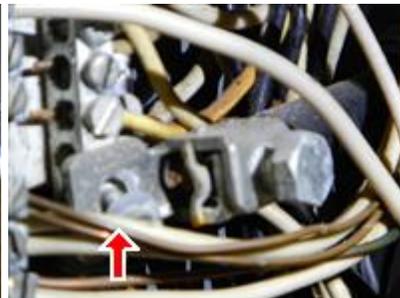
3. (PBOND) The primary electrical bond is loose at the electrical panel connection. Bonding the pipes of the plumbing system provides protection against shock in the case of electrical wires coming in contact with them. It is advisable to ensure this very simple component as soon as practical.

6.2 Picture 3 Loose connection

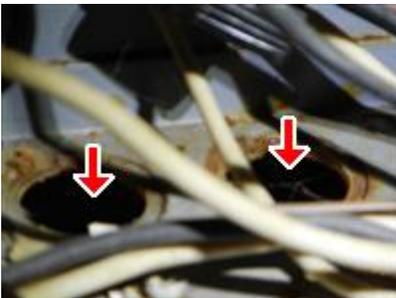
4. (KNOCK-OUT) The main electrical panel is missing one or more knock-out plates at the box. Any opening in the exterior of an electrical panel is an exposure hazard. It is advisable to cover these openings with knock-out covers. They come in standard sizes and are readily available at low cost.

6.2 Picture 4 Open knock-out holes

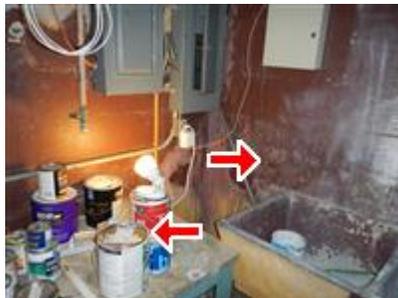
5. (CLEARANCE) There is not adequate clearance in front and sides of the main electrical panel. Modern safety standard for main panels require a minimum clearance for safe/unrestricted access for service and maintenance. It is advisable to establish at least 36 inches of such a clear area. For a definitive comment on this issue it is advisable to consult with a licensed electrical contractor.

6.2 Picture 5 Inadequate clearance

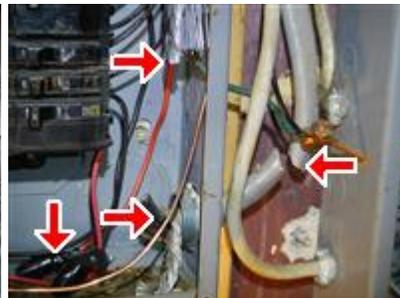
6. (OLD) There are a number of wires/cable in the electrical panels which are no longer properly terminate at the breakers, buses or a load device. This typically suggest an intentionally disconnected circuit. Any wires not currently used and properly connected in the main panels should be removed. For a definitive comment on this issue, it is advisable to consult with a licensed electrical contractor.

6.2 Picture 6 Old/obsolete wires/cables

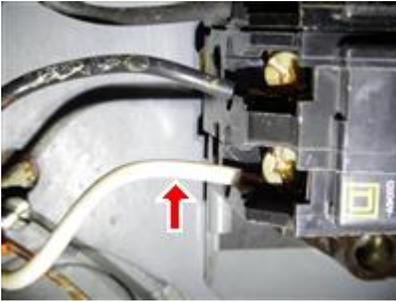
1. (N/H) There are at least three white wires in the main electrical panel being used as hot conductors. Wires in the panel are distinguished by color and, although the use of this white wire may be otherwise acceptable, its use as a black/hot wire needs to be indicated with a clear black marking (Sharpie or electrical tape, for example). For a definitive comment on the correctness of the wire and usage, one would need to consult a licensed electrician.

6.3 Picture 1 Neutral as hot conductor

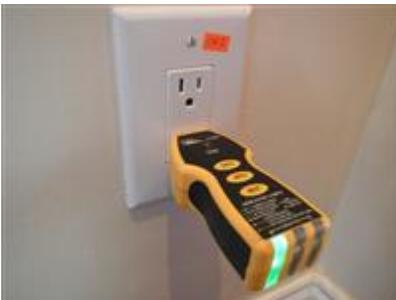
6.4 Picture 1 open ground receptacle

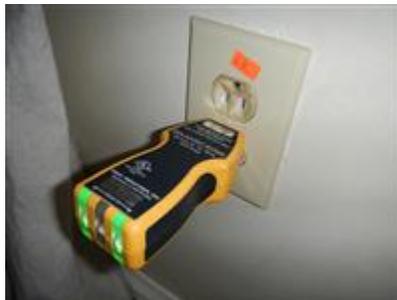
- 2. (LOOSE IN) The at least one receptacles at the Living Room are loose to the wall or have a loose connection such that a fixture plugged into it may not make a proper connection with the receptacle contacts. Standard practice is that all electrical connections be secure and correct for their intended function.

6.4 Picture 2 Loose receptacle

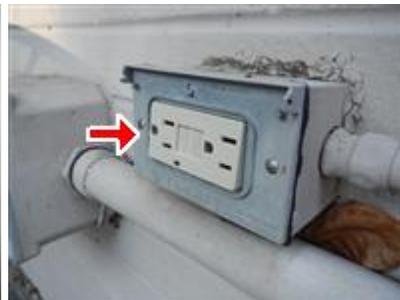
- (COVER) The receptacle box at the rear exterior is missing a cover. To avoid accidental exposure to the receptacle wires, it is advisable to attach a proper cover.

6.4 Picture 3 Missing cover

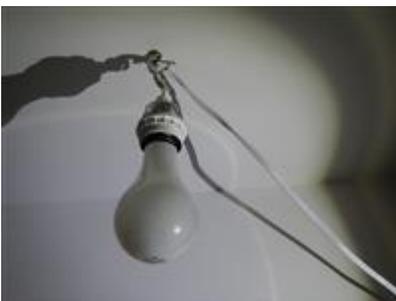
6.4 Picture 4 Unsafe fixture

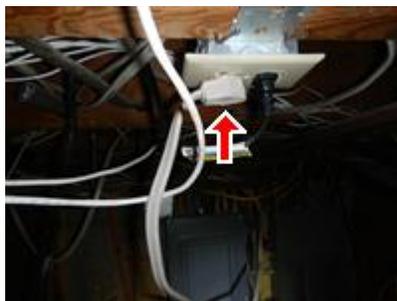
6.4 Picture 5 Unsafe extension cord

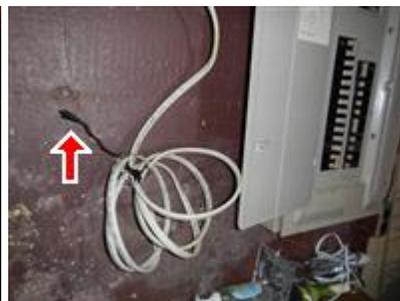
6.4 Picture 6 Exposed live wire

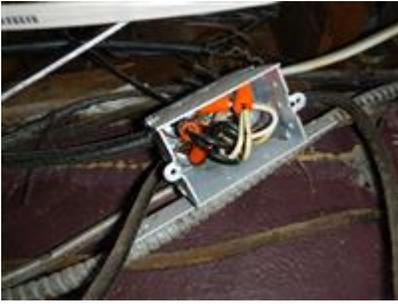
6.4 Picture 7 exposed wires

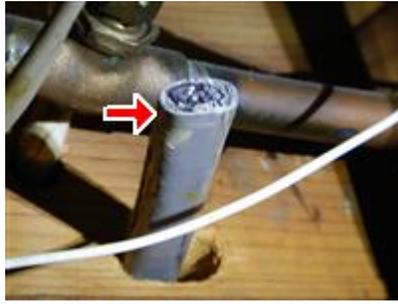
6.4 Picture 8 Ex. exposed electric

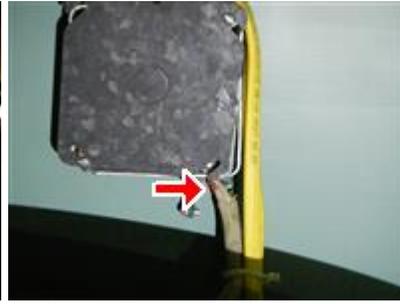
6.4 Picture 9 Exposed electric

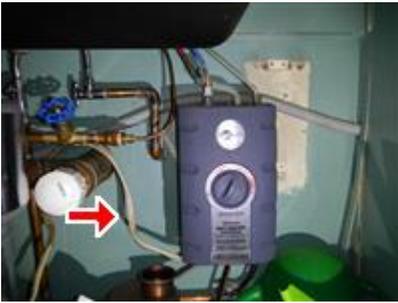
- (VULN) The electrical wiring under the Kitchen is vulnerable to impact/abrasion. It is advisable to relocate this run of wiring or protect the wiring with raceway or conduit (FYI).

6.4 Picture 10 Vulnerable wiring

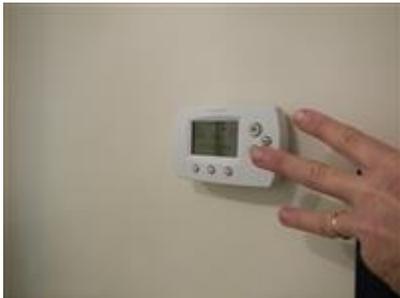
7.3 Picture 1 Three levels on one unit

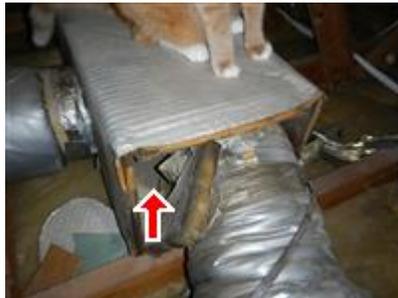
- (LEAK) There is a leak in the central air distribution duct at the attic. It is advisable to maintain a sealed distribution and return network to maximize the efficiency of the system as well as introducing unconditioned air into the house.
 - (STRAT) The air distribution for the central AC is stratified- much warmer upstairs than downstairs. We have not performed an evaluation of options or corrective measures. For a definitive comment on this issue, one would need to contact a licensed HVAC contractor (FYI).
 - (DIRTY) The disposable filters are dirty. A dirty filter puts unnecessary strain on the air handler and the heating/cooling system in general. It is advisable to install a clean filter and keep a maintenance schedule according to manufacturer specifications (FYI).

7.3 Picture 2 Gap in forced air

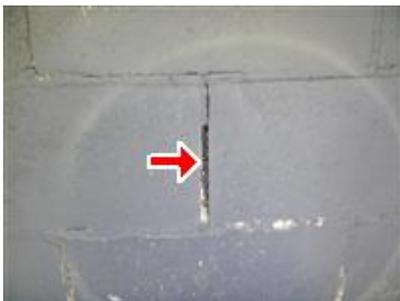
- (GAP) There is a gap in the firebox at the left side livingroom firebox. This creates a risk for flue gases to escape from the flue which is the safe, intended path out of the house. It is advisable to fill this gap. For a definitive comment on this issue, it is advisable to consult with a licensed chimney sweep/contractor.
 - (DAMPER) The fireplace damper at the Living Room is defective. It is advisable to repair/replace this damper and have the flue inspected by a certified chimney sweep to determine usability.
 - (SWEEP) We have done a quick visual inspection of the fireplace/chimney flue(s) as access permits. It is advisable at the time of any property changing ownership to consider scheduling a stage two inspection by a certified/licensed chimney sweep to eliminate any potential problems we could not see (FYI)

7.5 Picture 1 gap in firebox

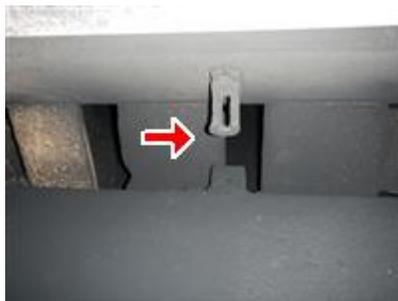
- (DAMPER) The fireplace damper at the Living Room is defective. It is advisable to repair/replace this damper and have the flue inspected by a certified chimney sweep to determine usability.
- (SWEEP) We have done a quick visual inspection of the fireplace/chimney flue(s) as access permits. It is advisable at the time of any property changing ownership to consider scheduling a stage two inspection by a certified/licensed chimney sweep to eliminate any potential problems we could not see (FYI)

7.5 Picture 2 No damper door

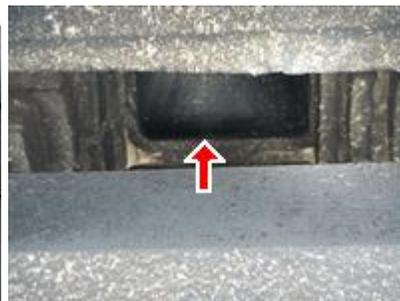
7.5 Picture 3 Time for flue maintenance

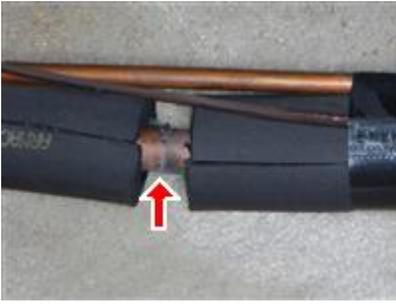
7.8 Picture 1 Insulation gap

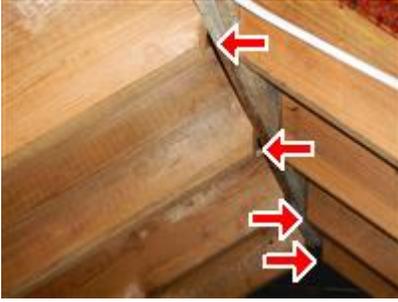
- (RIDGE) The ridge board of the roof is significantly smaller in width than the attached rafters. The support capacity is limited to the lesser of the two dimensions. We cannot determine if this roof is engineered to provide proper load support as is or, if the the smaller dimension of the ridge board is a defective application. For a definitive comment on this issue, one would need to consult with a specialist

9.6 Picture 1 Ex. missing bearing surface
